Hygroscopic Salts and Rising Dampness

The Salt Problem

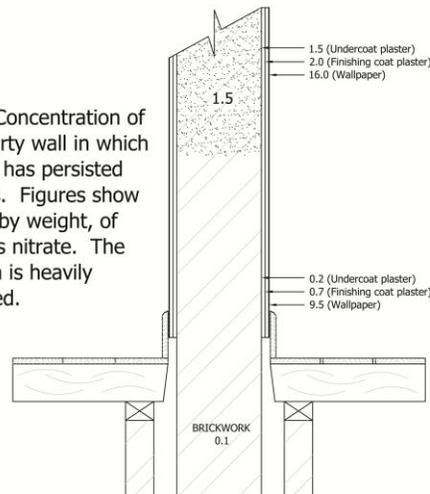
Figure (1): Concentration of salts in a party wall in which rising damp has persisted for 80 years. Figures show percentage by weight, of chloride plus nitrate. The shaded area is heavily contaminated.

dampness. An example of the pattern (or distribution) of salt accumulation is shown in Figure (1).

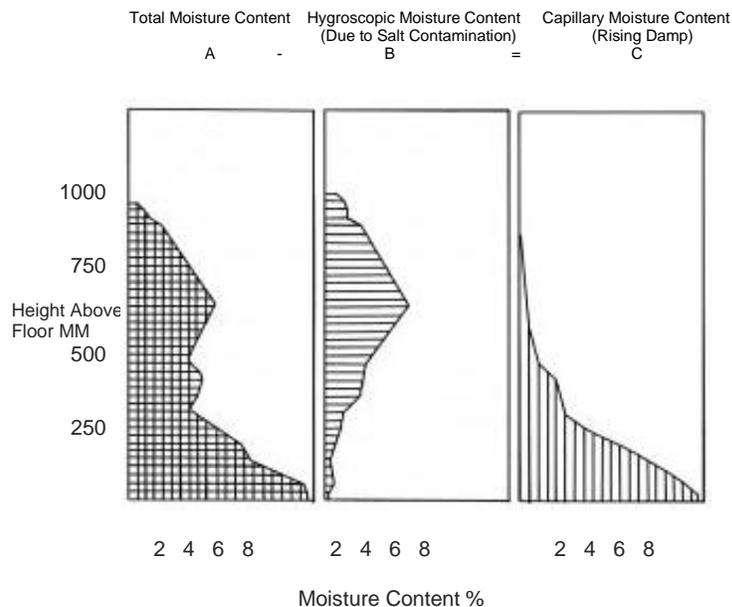
Figure (2): Graph (b) shows that the amount of water absorbed by the masonry from air is about 5% at 600mm above floor level. The hygroscopicity of uncontaminated masonry is 0.1-0.2%. The additional water absorption is due to salt contamination.

The amount of water absorbed by salt contaminated masonry, mortar or plaster will vary with the humidity of the air and the amount and character of the salt. A typical distribution of dampness in a wall affected by rising dampness is shown in Figure (2). The diagram shows in graph form, the moisture content of a wall affected by rising dampness:

A shows the total moisture content.

B shows the hygroscopic moisture content measured at 75% relative humidity. This represents the amount of water absorbed by the masonry from air at 75% relative humidity.

C shows the difference A-B and represents water in the wall due to capillary flow.
